List of key personnel interviewed EPA Internal Review Team of the Gold King Mine Spill, Colorado

Gold King Mine 2015 EPA Working Assumptions

Gold King Mine Flow Data and Chart

Photos and Google Earth Images

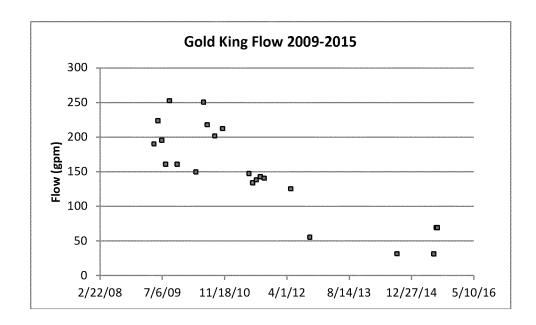
Variability of Gold King Mine Flow

Gold King Mine flow data is available from 2009 through 2014, with multiple sampling events from 2009 -2011 and fall sampling from 2012 -2014. Gold King Mine spring flow was not measured from 2012 to the present due to high snow and potential avalanche conditions, and flow was not measured during fall 2013 due to the government shutdown. Flow was also measured by START during 2014 and 2015 site visits.

For years with multiple flow measurements (2009, 2010, 2011), the Gold King Mine discharge varied by up to 45 percent within 1 year (2009), when the November flow was 45 percent greater than the August flow.

The Gold King Mine discharge annual average runoff flow varied from the annual average non-runoff flow by up to 22 percent (2010).

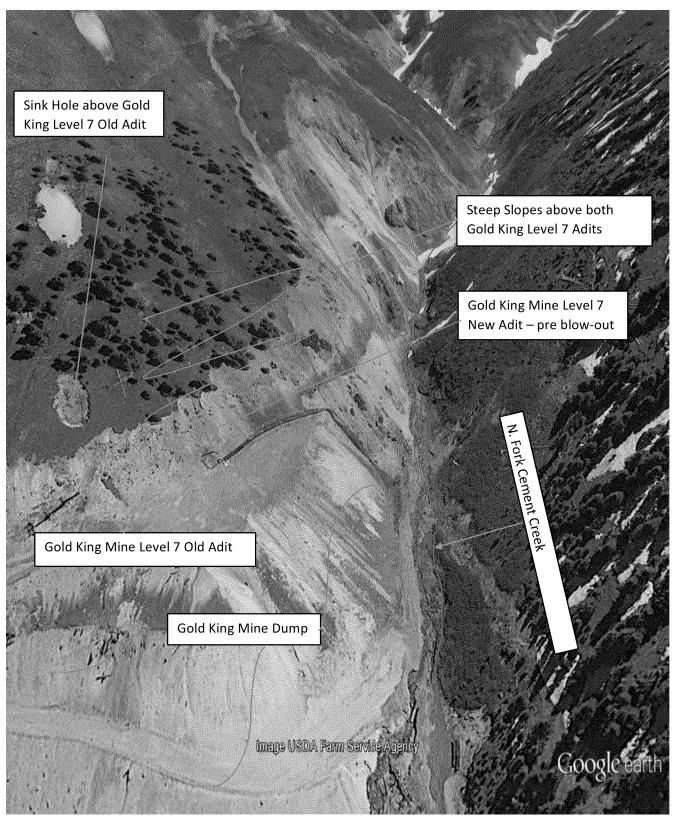
Photo 1 Google Earth June 2015 Image - Gold King Level 7 Adits and Mine Dump

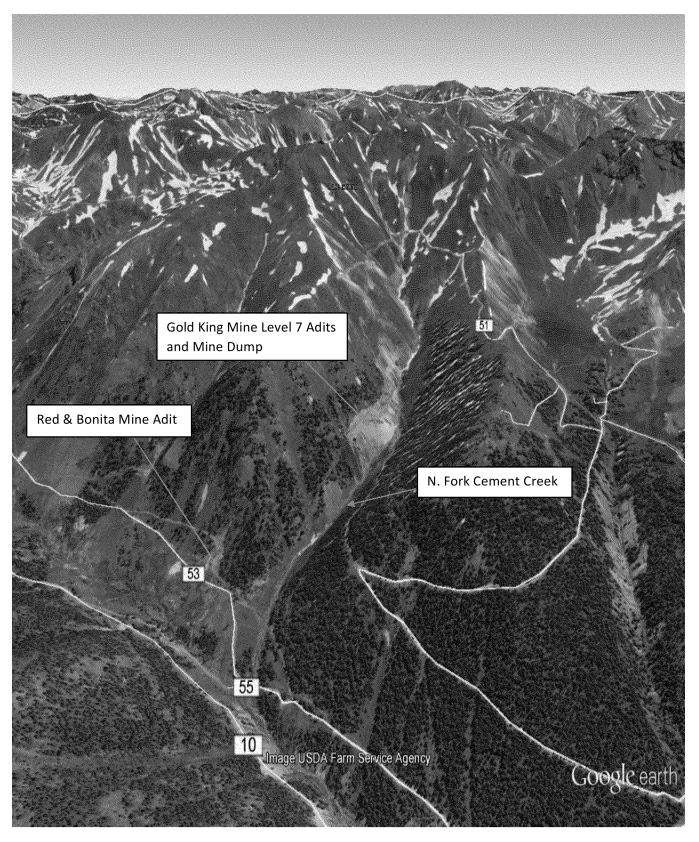
Photo 2 Google Earth June 2015 Image - Gold King Level 7 and Red & Bonita Mine Adits
